SERVICE BULLETIN

NO. **113A** DATE **2-3-99**

McDONALD'S VERTICAL CONTACT TOASTER (VCT-200) (P/N 7000202 Chain Guard & Wire Set Update Kit)

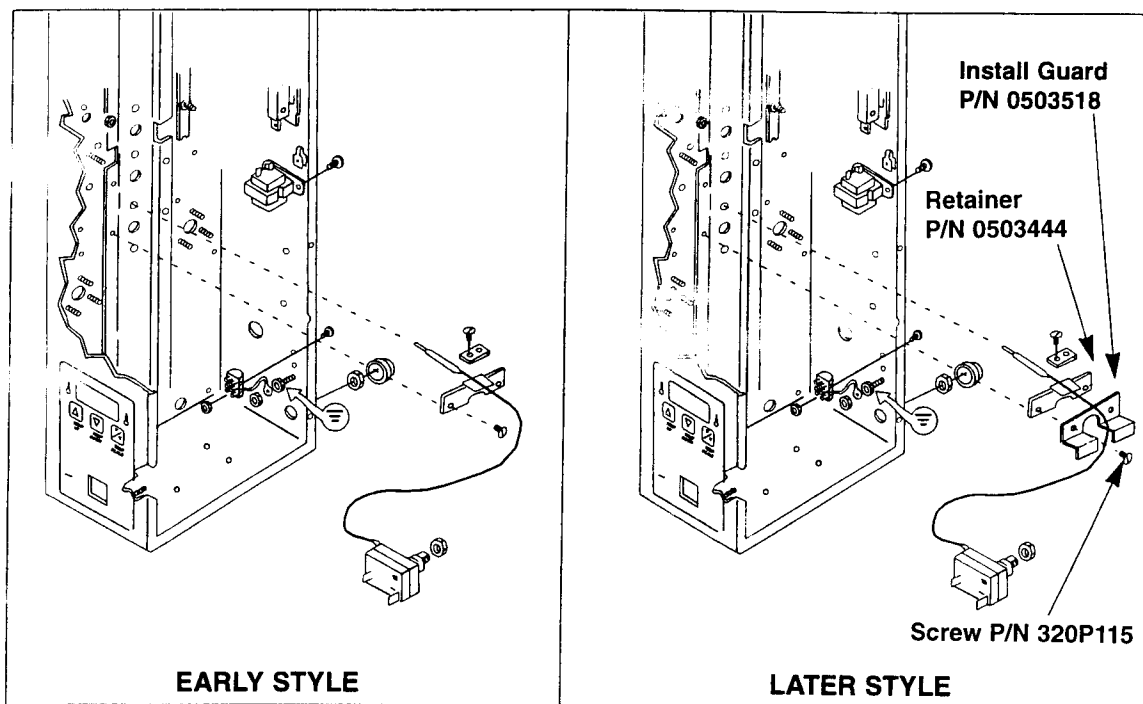
Figure 1

1. (P/N 0503518) Chain Guard: We have found that after the toasters have been in operation for several months, the drive chain stretches. Occasionally the chain will jerk or bounce. This jerking or snapping in turn can permit the chain to rise and touch the lower 200-volt connection of the platen heating element. Installing the chain guard eliminates this situation.

1. Turn power switch off and disconnect all electrical power from toaster.
2. Remove right side control cover (P/N 0503414).
3. Remove both screws (P/N 320P115) that fasten the high limit capillary retainer (PN 0503444) to the frame of the toaster. (Do not remove the top plate of the retainer)
4. Slightly lift the high limit capillary.
5. Starting from the right side of the control cabinet, thread the new chain guard (P/N 0503518) in between the capillary tube and the white wires going to the lower platen terminals.
6. Align the holes of the chain guard (0503518) with the corresponding holes of the retainer.

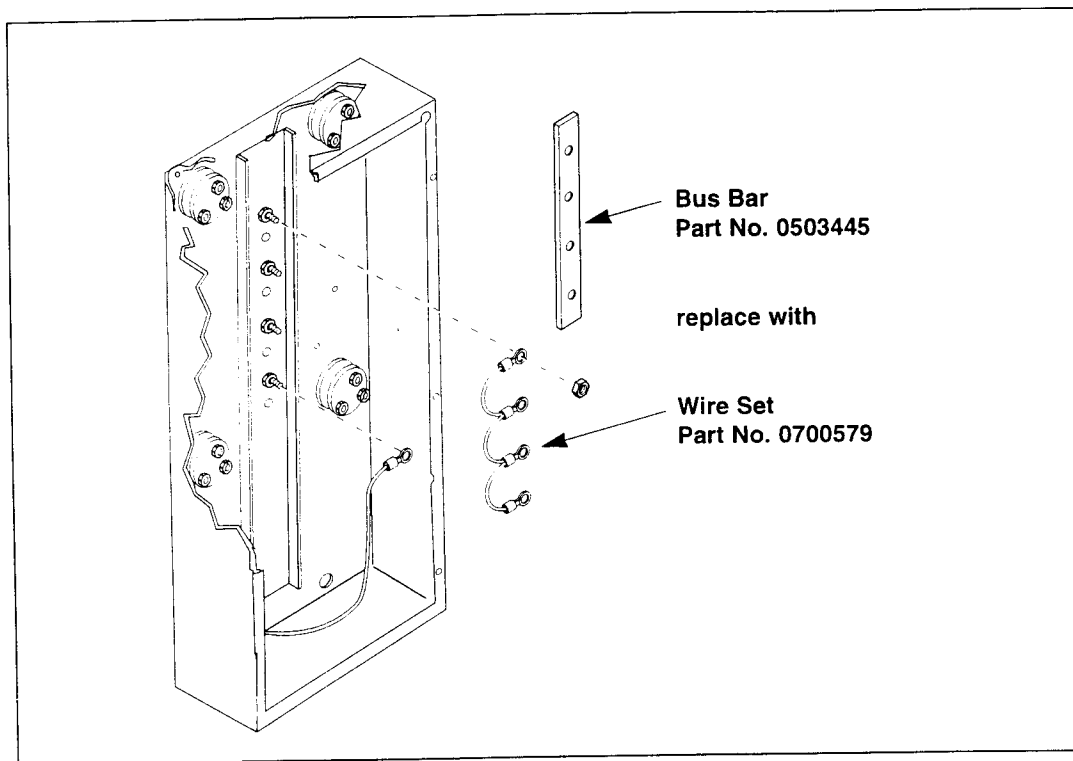
**FIGURE 2
BUSS BAR REPLACEMENT**

2. (P/N 0700579) Wire Set: The buss bar (P/N 0503445) is connected to all four return element legs of the platen. These legs usually have different lengths. This has caused stress on the buss bar, which in turn permits the nuts to loosen and cause a loose connection. The wire set eliminates this situation.

- 1) Turn toaster off and disconnect all electrical power to the toaster.
- 2) Remove both knobs (P/N 2100253) from the tensioners located on the left side of the toaster.
- 3) Remove the left side cover (P/N 0503416).
- 4) Remove the Buss Bar (P/N 0503445) and discard (See Fig. 2).
- 5) Install the wire set (P/N 0700579) as shown in Figure 2.
- 6) Turn power on and test.
- 7) Replace side cover and tensioner knobs.

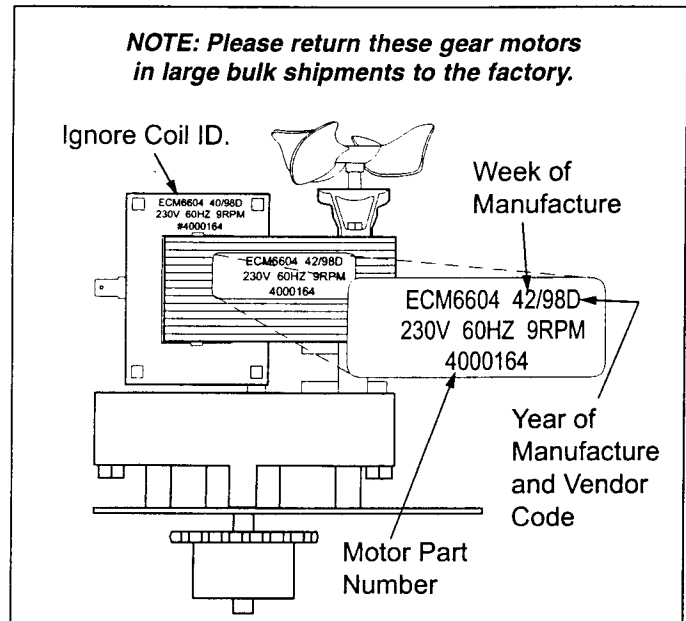
Figure 1. Identifying Motor that MUST Be Changed

The basic gear motor part number is 4000164. This part number, along with the *Lot #* and *Date of Manufacture*, can be found on the white tag attached to the motor laminations on the side of each motor (Figure 1).

NOTE: ONLY MOTORS MANUFACTURED PRIOR TO WEEK 3 OF 1999 REQUIRE CHANGING. MOTORS MANUFACTURED FROM WEEK 3 OF 1999 AND LATER FEATURE THE IMPROVED DESIGN AND SHOULD NOT BE CHANGED. SEE FIGURES 1 & 2 FOR MOTOR IDENTIFICATION.

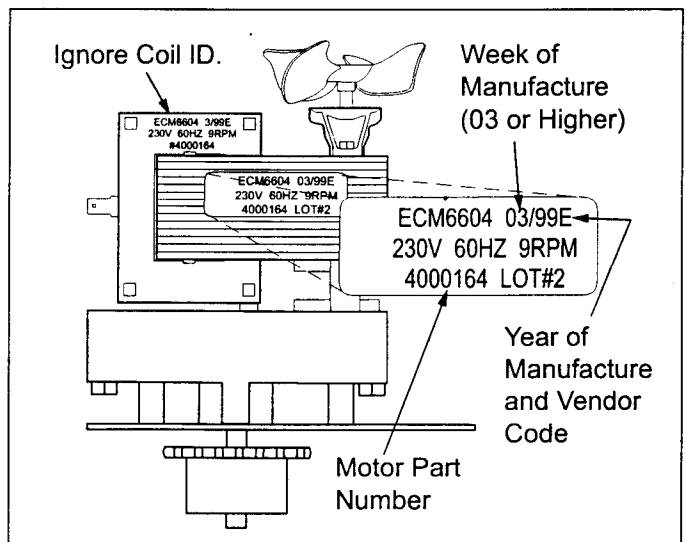
**Figure 2. Identifying New Improved Motor
DO NOT CHANGE**

The new, improved gear motors have been shipped to you for your inventory since the end of January, 1999. These improved motors will be from Lot #2 or Lot #3. In a few weeks, we will change the tag color on these from white-with-black lettering to blue-with-white lettering for easier identification.

It is very likely that you will encounter VCT-200's in the field built with the new motors. DO NOT CHANGE THEM! Please state on the Conveyor Verification Form [Project Warr 0199](#) that the motor was changed previously.
