# SERVICE BULLETIN

NO. 267

**Subject: McDonalds Universal Toaster (UTX-200) Bearing Retainer Upgrade Kit P/N 7000538**

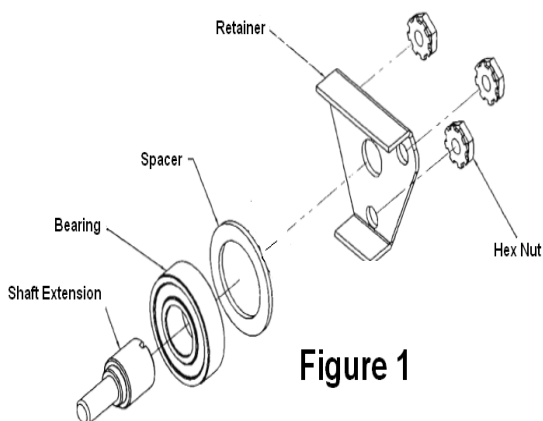
**Figure 1**

An area of concern involving the rear Vertical Conveyor Door Assembly has arisen. The Shaft Extension bolt (see Figure 1) that is located on the Power Cord (see Figure 2) side of the unit may possibly grind against the inner wall of the steel retainer as it rotates. Eventually, the extension bolt may cease and snap off within the main shaft. If this occurs, the Vertical Conveyor Door Assembly will not be sturdy when opened and will lean towards the side of the snapped extension bolt. We are taking a proactive approach in an attempt to prevent snapping of the extension bolt.

Please inspect the rear Vertical Conveyor Door. If it is unstable on the bottom left hand side call AJ Antunes immediately. If the door is stable, then remove the side panel that is towards the power cord side (see Figure 2) and remove the 3 hex nuts, retainer, spacer, and ball bearing. Install the new Bearing Retainer Kit. The kit will have a detailed instruction sheet.
